INDOOR AIR QUALITY ASSESSMENT

**Granby Fire Department
250 State Street
Granby, Massachusetts**

Prepared by:
Massachusetts Department of Public Health
Center for Environmental Health
Bureau of Environmental Health Assessment
Emergency Response/Indoor Air Quality Program
November 2004

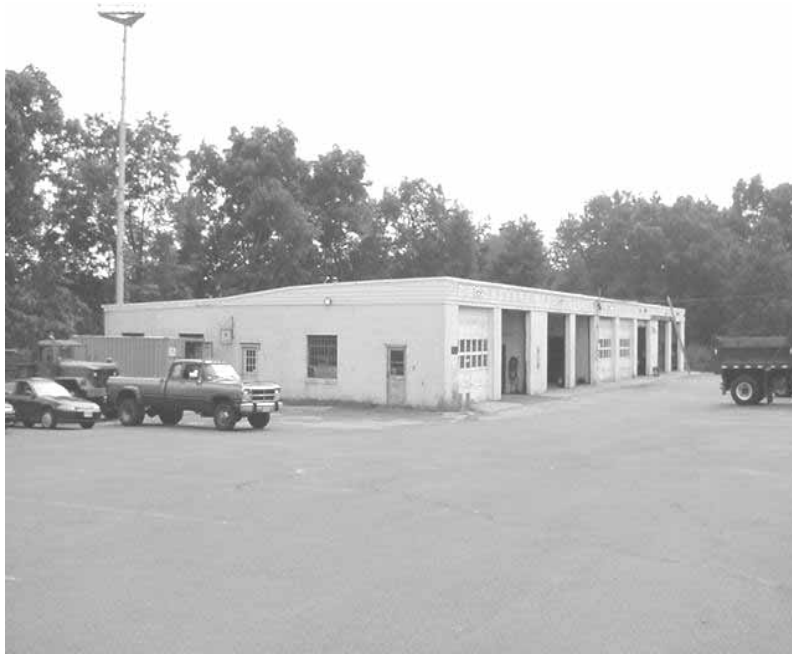
Picture 1

The firehouse is a section of the Granby Public Works garage (the garage), a one story, cinderblock building constructed during the 1950s-1960s (Picture 1). The garage contains nine vehicle bays. GFD fire and rescue equipment is housed in the three westernmost bays of the garage. GFD offices are located in a space behind the ambulance bay. The GFD offices consist of a command room, day room and restroom. The GFD spaces are heated by a furnace/air handling unit (AHU) located in a basement area below the day room. As reported by GFD staff, the restroom had experienced a substantial plumbing leak causing damage to the restroom floor and a basement storage area adjacent to the AHU room. Windows in the day room are openable. The AHU room is accessible via a bulkhead door (Picture 2) located outdoors at the rear of the building.

Granby Public Works Garage

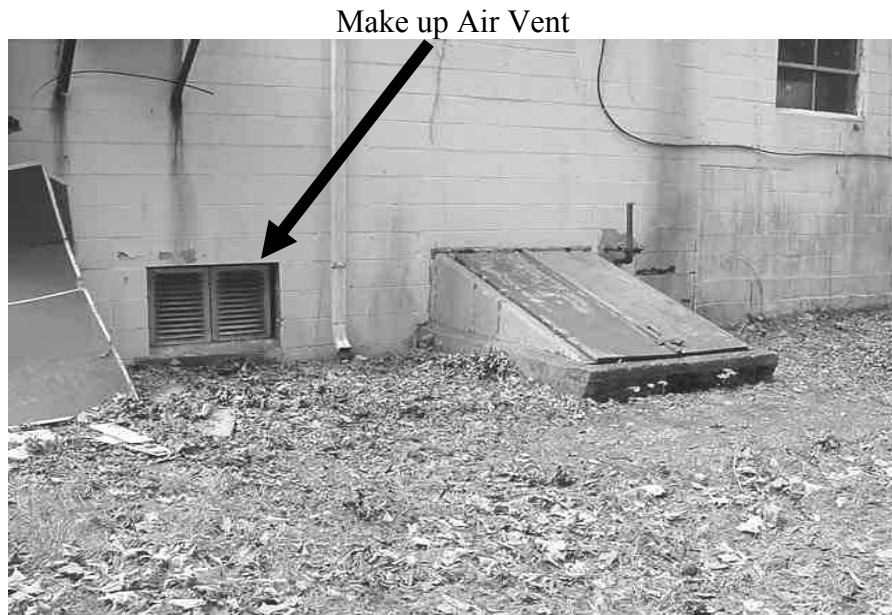
Picture 2

- A make up air vent for the furnace (Picture 2) is located on the exterior wall of the AHU room. This vent allows hot, moist air to penetrate into the AHU room during the summer. This condition allows for the basement floors and adjoining walls to generate condensation. Condensation wets accumulated dirt and other materials in this room, causing mold growth.

Bulkhead Leading To AHU Room at Rear of the Building

11. Render the window air conditioner installation water tight.
12. Repair the seal on the bulkhead to prevent water penetration into the basement.
13. Install a door to separate the basement storage area from the AHU room.

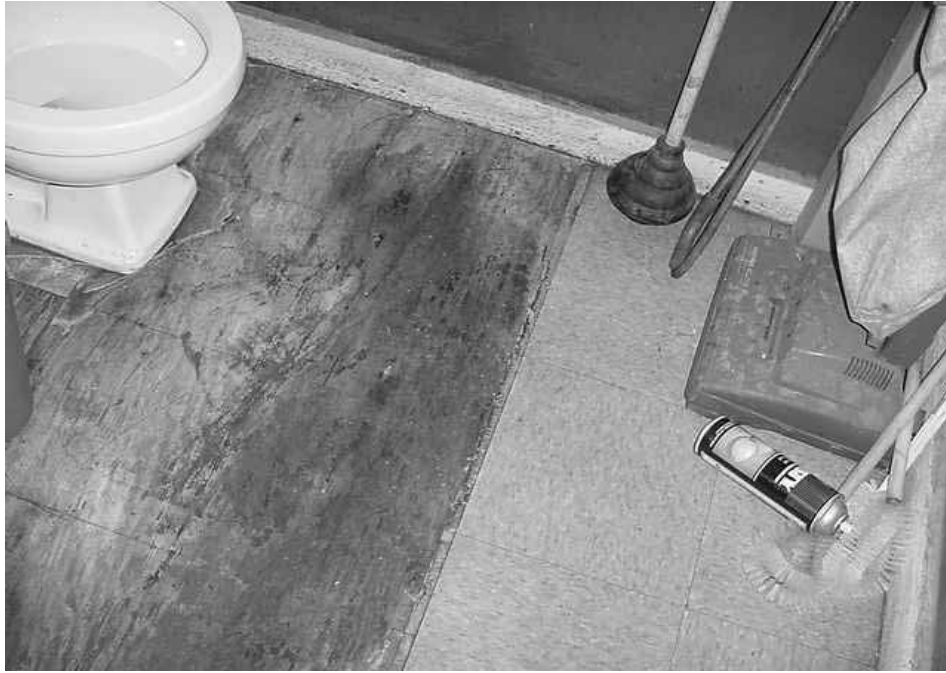
Picture 3

The GFD has a number of areas that have either water-damage or mold contaminated materials. As reported by GFD staff, the bathroom had flooded from a toilet overflow, which damaged the floor (Picture 3). Water from the restroom flood penetrated through the floor, wetting building components located in the storage area in the basement. The ceiling of the storage appeared to be gypsum wallboard (GW), which had collapsed onto the floor. The water-damaged GW appeared to be mold colonized. If this is the case, water-damaged materials wetted by this leak should be considered as contaminated with sewage. Sewage contaminated materials require special handling and cleaning to prevent the spread of disease to handlers of these materials (CDC, 1994).

Water Damaged Floor of GFD Restroom

1. Water-damaged materials in the basement should be considered contaminated with sewage. Consider consulting a professional flood restoration firm. We strongly advise that untrained individuals /employees avoid contact with any potentially contaminated standing water or materials on the floor of this storeroom.
2. Remove mold colonized and water-damaged ceiling tiles, fiberglass insulation and GW in occupied areas and engine bays.. These materials should be removed in a manner consistent with *Mold Remediation in Schools and Commercial Buildings* published by the US EPA (2001). Copies of this document can be downloaded from the US EPA website at:

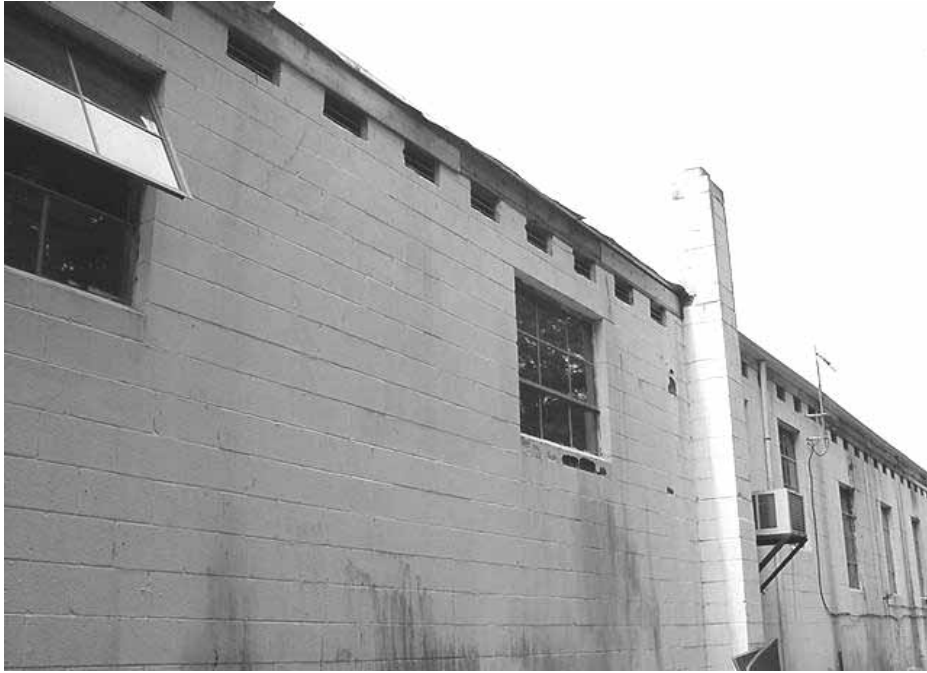
Picture 4

- The oil tank located in the AHU room. The oil residue top of the tanks is covered with white material that appears to be mold.
- The garage originally had a gutter/downspout system to collect rainwater from the slightly pitched roof. The gutter was removed (Picture 4), which has allowed water to pour over the rear of the building. Rainwater strikes the bulkhead at the base of the wall, allowing for moisture to penetrate into the AHU room through a damaged seal along the bulkhead (Picture 5). This lack of rainwater drainage also allows for water to strike the casing of the window-mounted air conditioner in the day room, resulting in moisture penetration through the window or adjoining cinderblock.

Roof Edge at Rear of Building with Removed Gutter Downspout

1. Examine and repair water drainage/integrity of the roof.
 - a. Repair the roof surface.
 - b. Repair flashing at rear of the roof.
 - c. Install gutter/downspout to drain rain from the roof.
2. Once the roof is repaired, replace all missing ceiling tiles and insulation above the suspended ceiling.

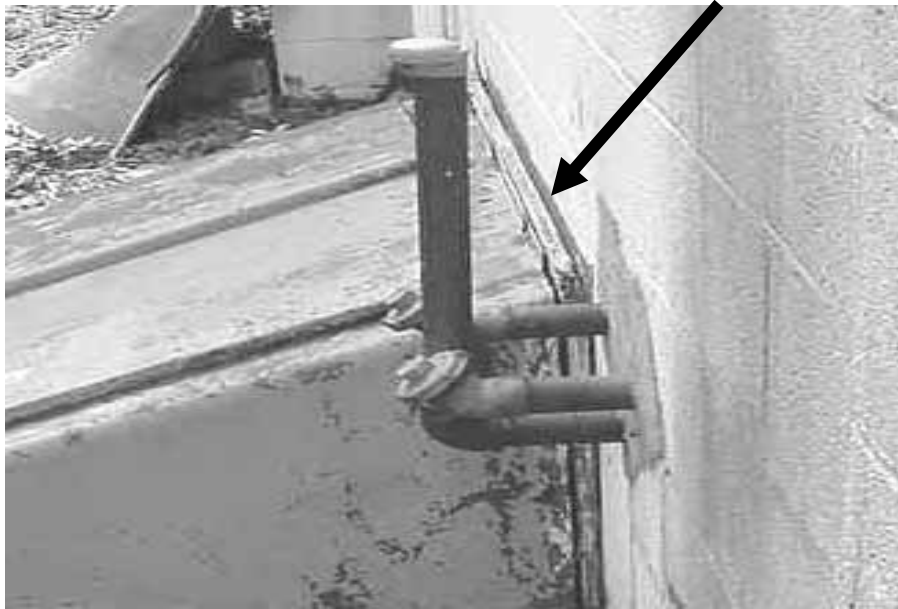
Picture 5

Space between Bulkhead and Exterior Wall

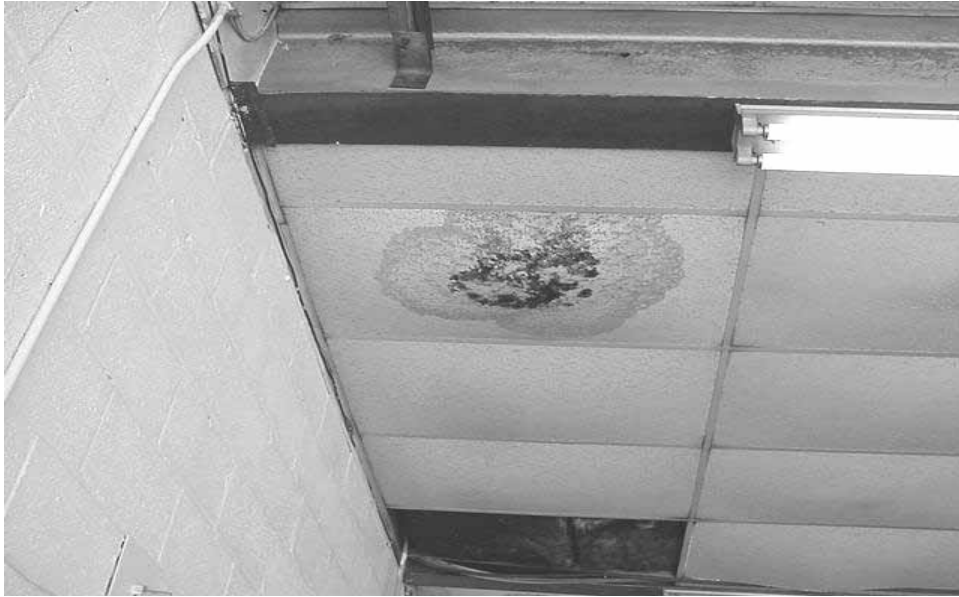
Picture 6

- A suspended ceiling is installed in the engine bay. A substantial number of ceiling tiles were either mold colonized (Picture 6) or water-damaged. The source of

water damaging the ceiling tiles appear to be leaks from the roof. When the AHU is operating and exterior door is closed, mold particles/odors can be drawn from the engine bays into the AHU.

Mold Colonized Ceiling Tile in Engine Bay

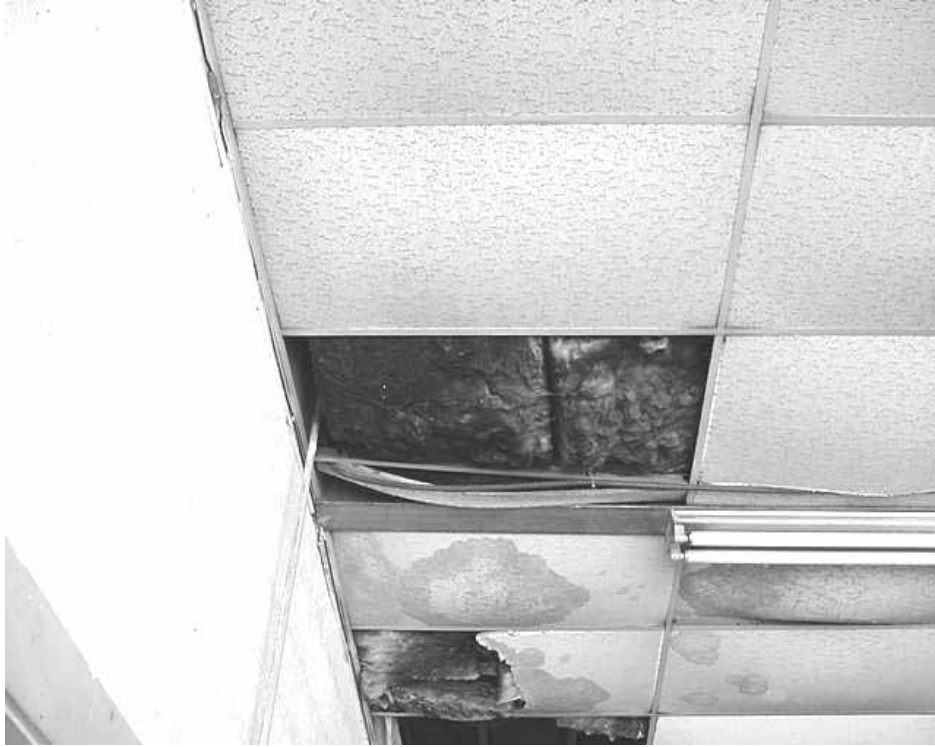
Picture 7

Of particular interest is vehicle exhaust. The firehouse is not equipped with a mechanical exhaust system to remove exhaust from the engine bays during vehicle idling. Of note was the presence of heavily blackened fiberglass insulation (Picture 7) located above the fire apparatus. Although it is possible that the material has mold contamination, the pattern of

black discoloration observed on the ceiling system insulation suggests periodic and repeated exposure to vehicle exhaust contributing to occupant exposures to contaminants contained within the exhaust (e.g., carbon monoxide). This smoke residue can be a source of irritants associated with vehicle exhaust.

Blackened Ceiling Insulation above Fire Apparatus

9. Seal all wall penetrations in the interior wall shared between the GFD engine bays and the GPWD garage to prevent odor/contaminant migration.
10. Install exhaust ventilation fans in the rear walls of the GFD engine bays as well as the GPWD garage to vent exhaust odors from the building. Once installed, operate the vehicle exhaust ventilation system when vehicles are started.

3. Consider installing a ventilation system that consists of flexible hoses that attached to fire/rescue apparatus. This type of system mechanically vents vehicle exhaust directly from the engine bays.
4. Consider building a permanent/air tight wall so that the GFD and GPWD restrooms are separated. Install mechanical ventilation that vents each restroom outdoors.
5. Consider moving the oil tank out of the AHU room to prevent VOC entrainment by the AHU.
